**DEPARTMENT OF TRANSPORTATION**

Contract #: 04-0120F4Cty: SF/ALA Rte: 80 PM: 13.2/13.9File #: 99.28**WELDING INSPECTION REPORT****Resident Engineer:** Casey, William**Address:** 333 Burma Road**City:** Oakland, CA 94607**Report No:** WIR-027101**Date Inspected:** 26-Jan-2012**Project Name:** SAS Superstructure**OSM Arrival Time:** 700**Prime Contractor:** American Bridge/Fluor Enterprises, a JV**OSM Departure Time:** 1530**Contractor:** L & M Industrial Fabrications**Location:** Tangent, Oregon**CWI Name:** Tom Dreyer**CWI Present:** Yes No**Inspected CWI report:** Yes No N/A**Rod Oven in Use:** Yes No N/A**Electrode to specification:** Yes No N/A**Weld Procedures Followed:** Yes No N/A**Qualified Welders:** Yes No N/A**Verified Joint Fit-up:** Yes No N/A**Approved Drawings:** Yes No N/A**Approved WPS:** Yes No N/A**Delayed / Cancelled:** Yes No N/A**Bridge No:** 34-0006**Component:** Tower Head Parapet**Summary of Items Observed:**

CCO: 196 - Description: Construct parapet walls at the Tower Heads

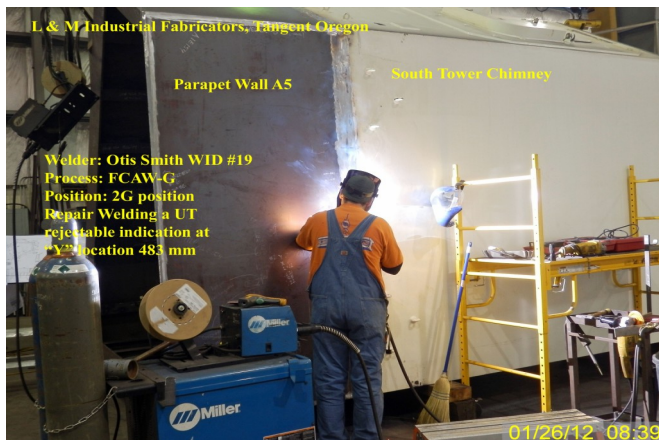
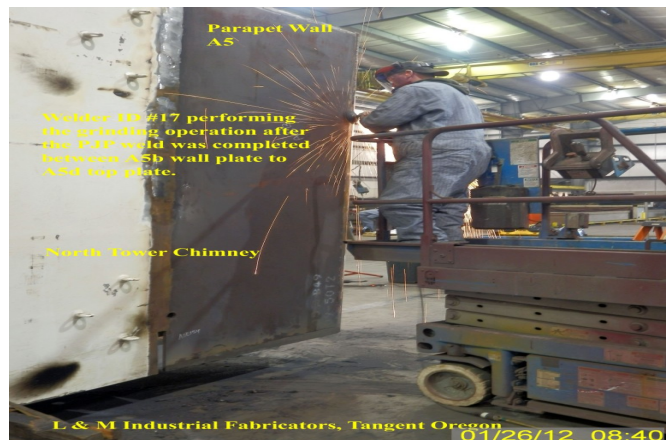
This QA Inspector observed L & M Industrial Fabricators Quality Control (QC) NDT Inspector Leo Jim performing NDT Ultrasonic Test (UT) inspection on the complete-joint penetration (CJP) corner-joint groove weld. The NDT was performed in accordance with L & M Industrial Fabricator's Weld Quality Control Plan (WQCP) - ABF Submittal 2510 Rev. 1. The weld joint numbers inspected and the QC NDT Inspector's test results were:

A4a base plate CJP corner joint welded to A4b wall plate- No UT Longitudinal or Transverse Indications detected.  
A5a base plate CJP corner joint welded to A5b wall plate- (1) UT Transverse Linear Indication detected.  
A6a base plate CJP corner joint welded to A6b wall plate- (1) UT Transverse Linear Indication detected.  
A7a base plate CJP corner joint welded to A7b wall plate- No UT Longitudinal or Transverse Indications detected.  
A8a base plate CJP corner joint welded to A8b wall plate- No UT Longitudinal or Transverse Indications detected.
